Purpose: CERCLA Site Inspection

Site: Fineline Paint Corporation

Date of Inspection: August 6, 1987

Report Date: July 1, 1988

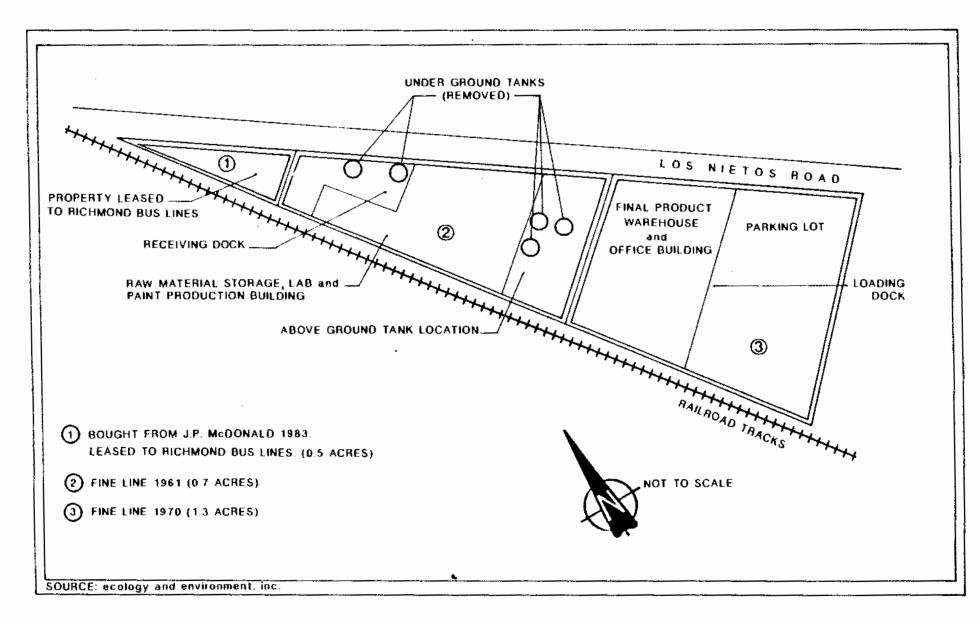
FIGURE 2
FACILITY MAP

On December 24 to December 31, 1986, five underground storage tanks were excavated at Fine Line by Petroleum Industries Consultants (PIC) (see Facility Map, Figure 2 and Underground Tanks, Table 2).
